Description: Tail light  
Part Number: 311048-311092  
Application: 2007-2008 Toyota Tundra

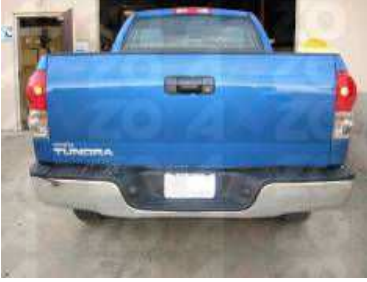
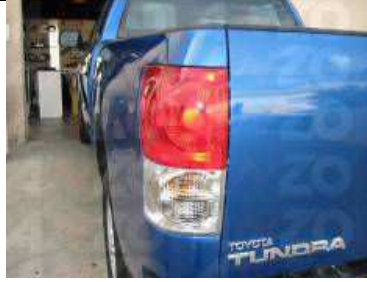
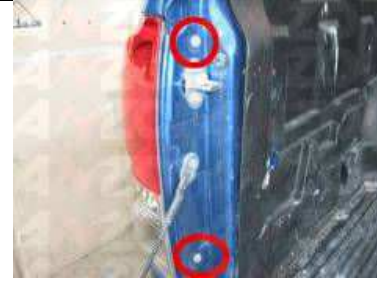
Tools needed: T27 Torque bit  
socket.

Step 1: Use the t27 torque bit  
socket to remove the two  
screws holding in the tail light.

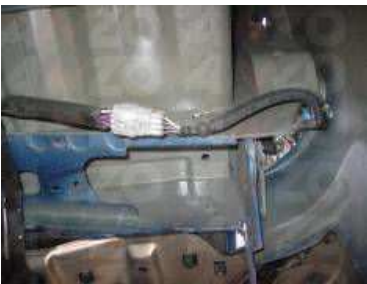
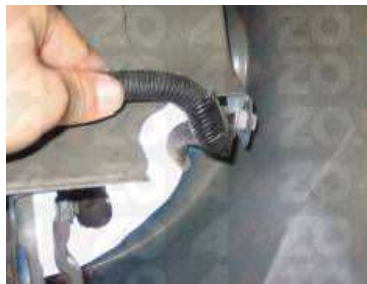
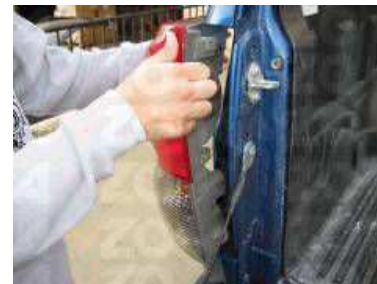
Step 2: Under the vehicle bed  
unplug the wire harness.

Step 3: Unclip the wire  
harness from the frame.

Step 4: Take the tail light off  
from the vehicle.

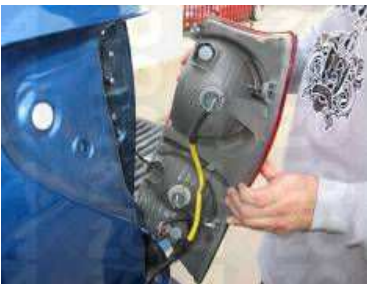
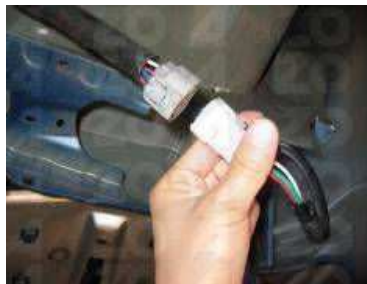
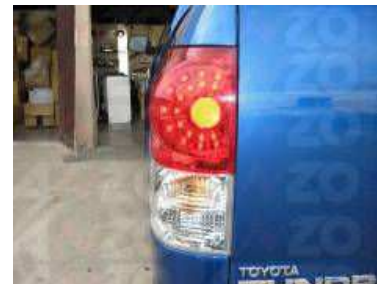
Step 5: Put in the new Anzo  
led tail light into the vehicle.

Step 6: Plug in the new Anzo  
wire harness into the original  
socket of the vehicle.

Step 7: Test all functions  
making sure they work  
properly before driving.
