Description: Tail Lights  
Part Number: 311047-311080-311081  
Application: 2007.5-2013 Chevy Silverado

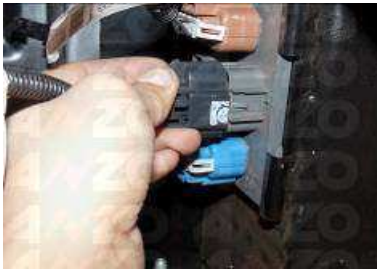
Step 1: Under the vehicle bed  
unplug the wire harness for the  
tail light.

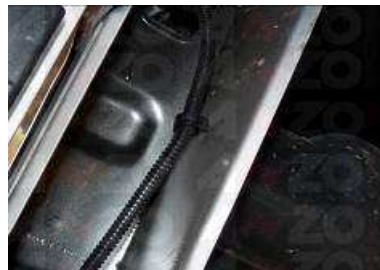
Step 2: unclip the wire from the  
plastic clips.

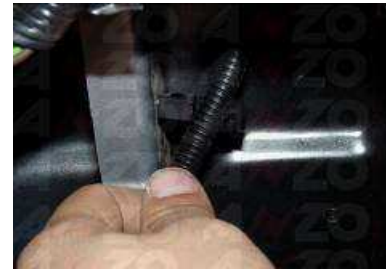
Step 3: Use the phillips  
screwdriver to remove the two  
screws holding in the tail light.

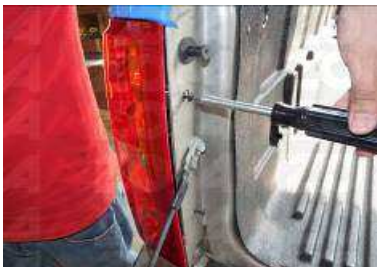
Step 4: Remove the tail light.

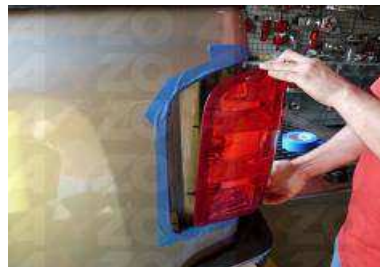
Step 5: Pull the wire out from  
under the bed.

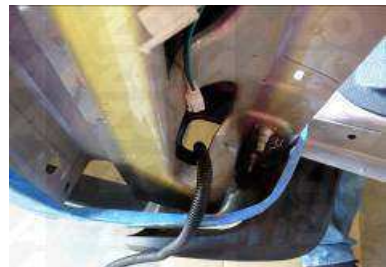
Step 6: Peel off the protective  
cover from the resistors and  
place in the two holes onto the  
frame of the body.

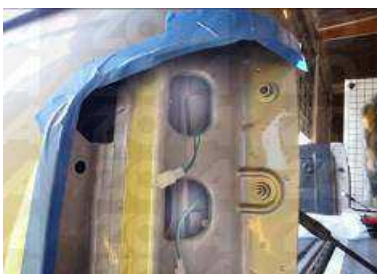
Step 7: Plug the resistors in and  
the wire harness into the circuit  
board under the bed.
